Micro-piles halt further property subsidence

Client: Private homeowner

Location: Wycliffe Avenue, York

Engineers: Helifix

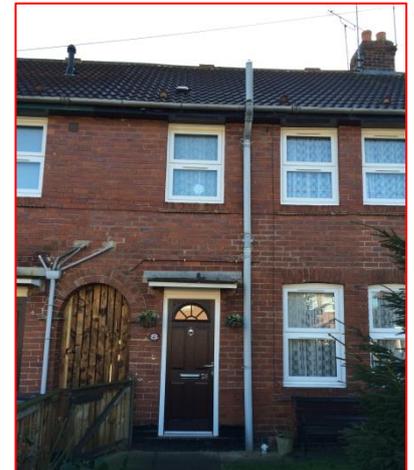
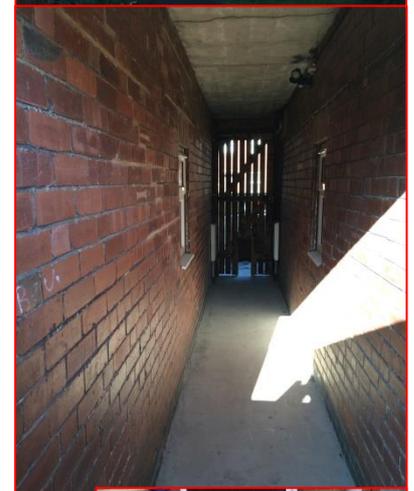
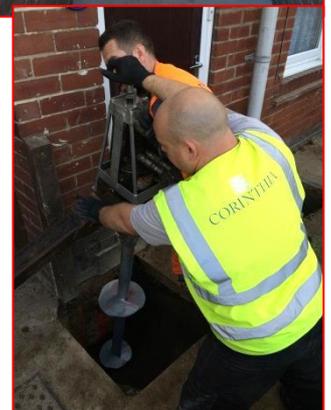
This two storey mid terrace property, of solid wall construction, was suffering from subsidence that was affecting the wall bordering the narrow covered passageway between residences, known as a ginnel.

The movement, which affected the mid to rear section of the passageway, was considered to be progressive. It had resulted in 40mm of subsidence, causing the kitchen floor to slope and producing cracking in some bed joints and around the ginnel opening.

A reliable means of stabilising the property was required that would also prevent further movement. In addition, the 1m wide narrow ginnel with low headroom severely restricted access and limited the possible repair options.

Helifix Dixie pipe piles provided the ideal solution as this ICC certified micro-pile system can be installed in restricted areas using just lightweight hand-held equipment. They are simply screwed into the ground and produce no spoil removal or vibrations.

- Comprehensive soil investigations were not possible so the piles were installed until the drive head gauge achieved a reading of 2025-2050 PSI. This ensured that suitable strata had been reached and the ultimate load bearing capacity would be a minimum of 225kN, including a safety factor of three.
- A total of eight micro-piles, with triple lead helices sections, were installed to a depth of 7m and at 1m-1.5m centres. Six piles were installed beneath the ginnel wall and one each next to the front and back doors.
- Holes were dug adjacent to the foundations and notches cut into the wall's footings. Adjustable 'L' shaped brackets were fitted to the piles and placed under the foundations. They were then jacked up until the specified safe working load was achieved, with the piles then fully supporting the building loads.

Operating in cramped conditions, the Dixie micro-piles were rapidly installed to stabilise the property and restore structural integrity.
