HELIFIX

Retrofit Helical Wall Ties and
Reinforcements for Seismic Upgrades

Seismic Upgrades

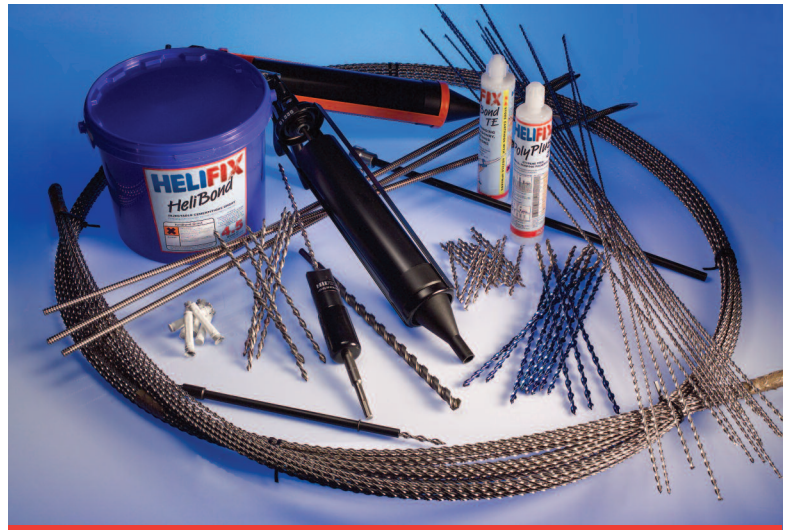
Crack stitching

HeliBar reinforcement may be installed in long lengths to add strength by tying masonry together, stitch across existing cracks, distribute load and improve ductility.

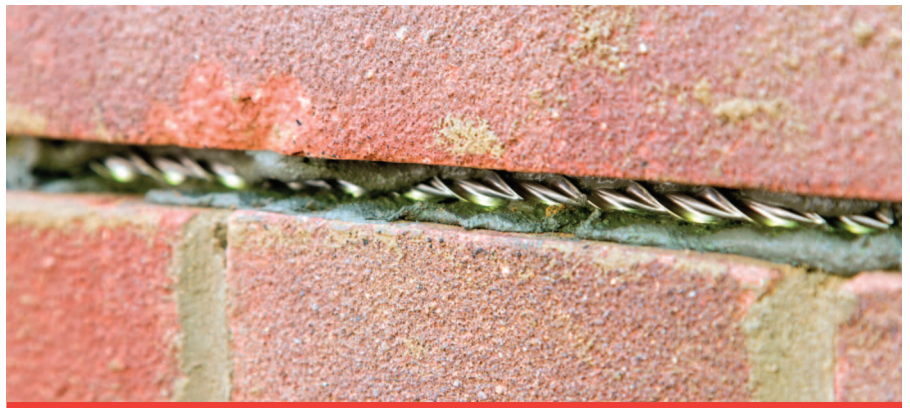
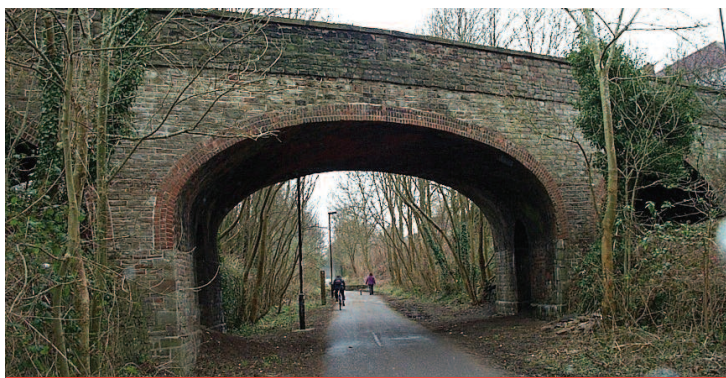
Securing brick arches and lintels

When used in combination with HeliBar reinforcement, Helifix ties and fixings can be installed to achieve positive results across a wide variety of applications from replacing wall ties and restoring structural integrity to individual masonry panels, to adding strength and ductility to complex masonry structures like arch bridges and tunnels.
